Manhole Inspection Summary

Manhole # S39Y1_016MH

Inspection ☐ Is Incomplete Rating: **4) Poor**

Location Address: **522 E. Garrett St.**

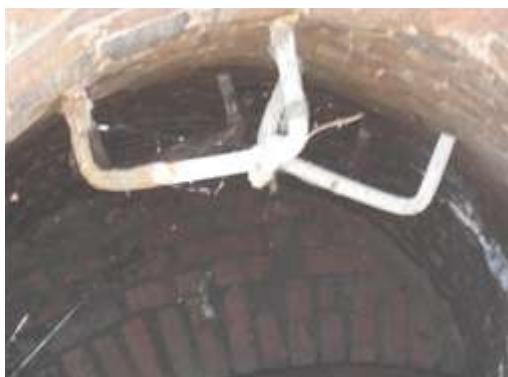
Steps

Count: **5** Missing: **0** ☒ **Corroded**

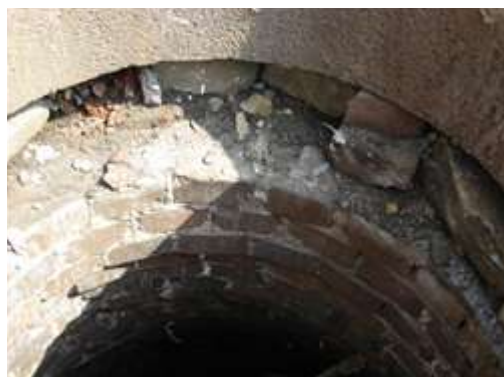
Defect 1

Condition: ☐ Sound ☐ Cracked ☐ Root Intrusion ☐ Loose Brick ☒ **Deteriorated**

Infiltration: ☐ None ☒ **Joint** ☐ Cracks ☒ **Mortar** ☐ Roots ☐ Wall

Frame-Chimney Adjustment

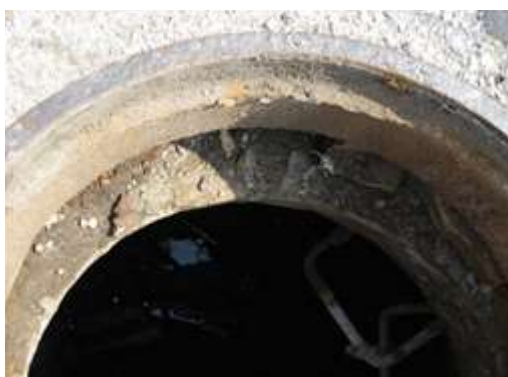
Defect 2

Offset: **3** (in.)

Frame Offset

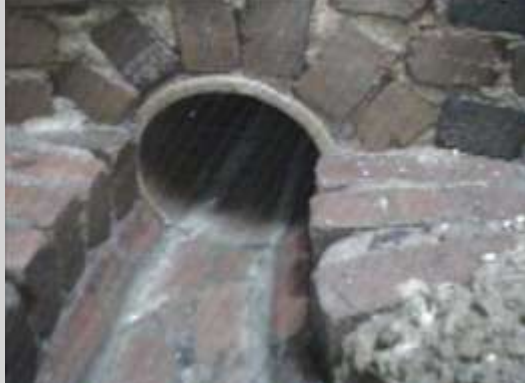
12 O'Clock Outflow

8 in. Circular Gravity Sewer
Pipe Out @ 12 O'Clock

Pipe Height: **9.6** (in.) Rod and Bar (Angled)
Pipe Material: **Clay** ☐ Pipe Lined
Invert Depth: **10.68** (ft.) Flow Characteristics: **Fast**
Deposits: ☒ None ☐ Mud ☐ Sludge ☐ Debris ☐ Grease
Silt Depth: (in.) Deposits Extent:
Infiltration: **None** Pipe Seal Cond: **Sound**

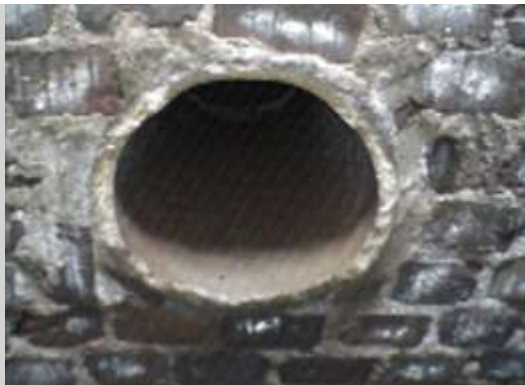
3 O'Clock Inflow

8 in. Circular Gravity Sewer
Pipe In @ 3 O'Clock

Drop In @ 3 O'Clock

Pipe Height: **8.4** (in.) Rod and Bar (Angled)
Pipe Material: **Clay** ☐ Pipe Lined
Invert Depth: **8.34** (ft.) Flow Characteristics: **None**
Deposits: ☒ None ☐ Mud ☐ Sludge ☐ Debris ☐ Grease
Silt Depth: (in.) Deposits Extent:
Infiltration: **None** Pipe Seal Cond: **Sound**

Drop: **Outside** Rod and Bar
Angled: **Yes** Reading: **9.38** (ft.)
Inv Depth: **10.38** (ft.)

Drop Condition: **Open**

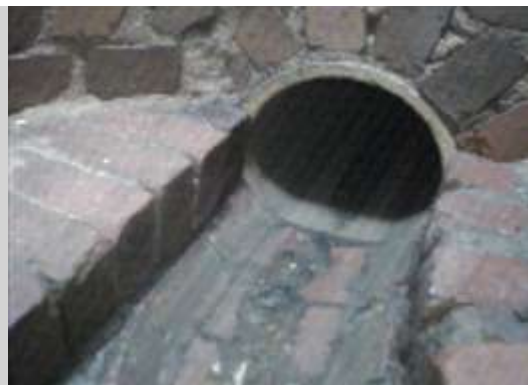
6 O'Clock Inflow

8 in. Circular Gravity Sewer

Pipe In @ 6 O'Clock

Invert Depth: **10.56** (ft.) Flow Characteristics: **Slow**

Infiltration: **None** Pipe Seal Cond: **Sound**
